## **Exploding the myth.**

### **EXAMPLE 1**

To investigate the vibration from a motor/ coupling set. This set being the inbye, or number 2, set of a pair; part of a new installation.

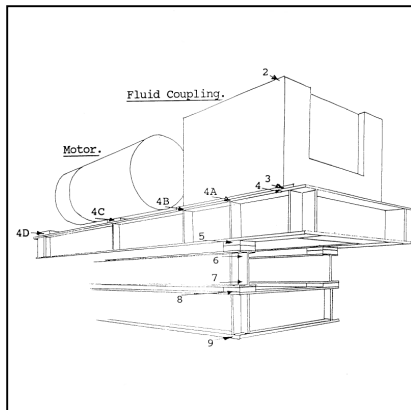
**Fig 1: Original Bed.**

Fig 1 is a schematic arrangement drawing showing the monitoring positions from where the data selected to illustrate the problem were collected.

The final design of the machine bed has two features, which allow the bed to flex, i.e. the girder spacer and the overhang of the top section beyond the support of the bottom section.

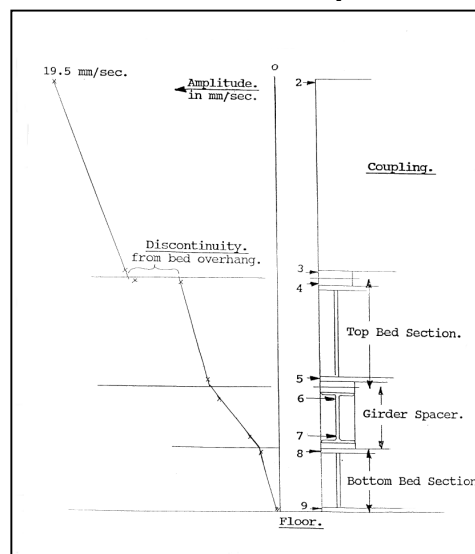
**Fig 2: Elevation View showing relative Vibration Amplitude**

Fig 2 shows the data plotted against a vertical cross section of the bed. The plot utilises data collected from points 2 to 9 inclusive, as identified on Fig 1. On the right of Fig 2 is an end view of the left hand side of the bed, looking from the coupling end.

The plot clearly shows that the girder spacer is considerably more flexible than the other sections of the bed.

Note the discontinuity which occurs where the top section of the bed is overhanging the other sections.

The velocity of 19.5mm/s from point 2, which is just above the output shaft means that the shaft is moving from side to side by approximately 0.75 mm, twenty five times per second.

(1) The girder spacer was not part of the original design, but an amendment, it is clearly the weakest of the three sections, even though the web had been gusseted between the flanges to increase the stability in this plane. It is estimated that this section alone allowed approximately 4.8 mm/s of the total of 19.5 mm/s.

(2) The overhang of the top section of the bed beyond the bottom sections has a very large effect on the resultant structure. The case of the fluid coupling is of a rigid design, the thickness of the material of the large end plate will produce a very stiff structure. The result of this should be that the top of the coupling should be moving very little more than the bottom and the amplitude line between points 2 and 3 should be near to vertical. This is obviously not the case.

Clues to what is actually happening are: the discontinuity from the bed overhang highlighted in Fig 2, and the deflection of the top flange of the top bed section between points 4 and 4B, shown in Fig 3.

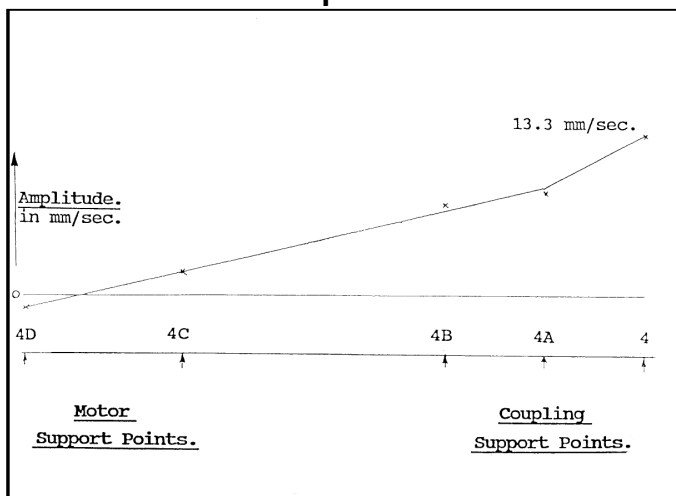
**Fig 3: Plan View showing relative Vibration Amplitude**

Fig 3 shows a plan view of the relative movement of the edge of the bed. This plot utilises data collected from points 4 to 4D inclusive, as identified on Fig 1.

Note the deflection of the bed at monitoring point 4A, which is above the supporting lower sections of bed while point 4 is overhanging.

There is good support in a vertical line up from the floor at point 9 to the top flange of the top bed section at point 4A but the coupling is not supported at 4A, it is supported at points 4 and 4B by the top bed section cantilevered from point 4A.

The designed strength of the top bed section is in the vertical direction not the horizontal-transverse direction. The immediate and obvious effect is that, under the forcing effect of the coupling, the cantilevered end of the bed, at 4, is moving, in the transverse horizontal direction, markedly more than its support at 4A. The bed girders are flexing — twenty five times per second.

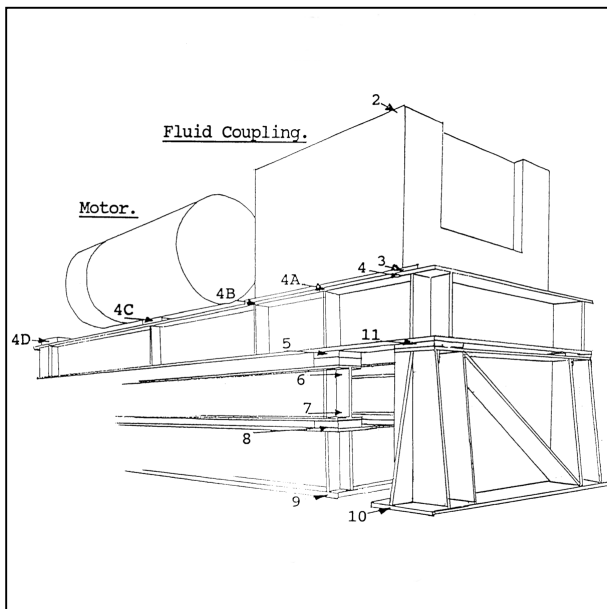
**Fig 4: Modified Bed.**

Fig 4 shows the new bed configuration and some extra monitoring points.

- (a) remove the force source by balancing the coupling to a better standard. This is possible but, if the original coupling is within the manufacturer's normal specification, then this would be a 'special'; also this course of action may prove expensive in money, time and effort
- (b) strengthen the bed in the transverse plane. This is by far the easiest, quickest and cheapest method since the overhung sections of the bed could be utilised for this.

The recommended bed modifications were carried out and the equipment was re-monitored.

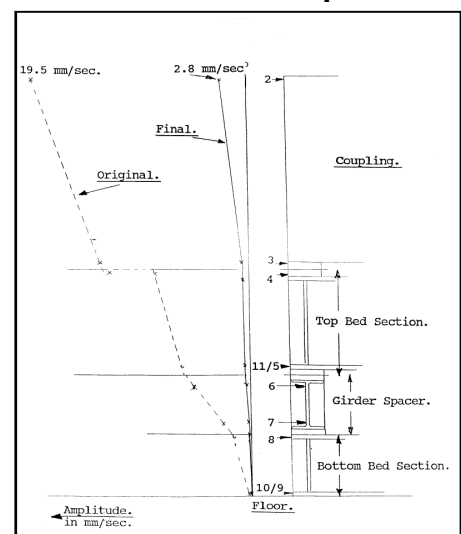
**Fig 5: Elevation View showing relative Vibration Amplitude**

Fig 5 shows the new data plotted against the old for the vertical cross-section of the bed.

The maximum amplitude of vibration, measured at the top

of the fluid coupling, is reduced to 2.86 mm/s rms. This is less than 15 per cent of its previous value and is well within acceptable values for this class of machine. It is also similar to that of the 'control' installation.

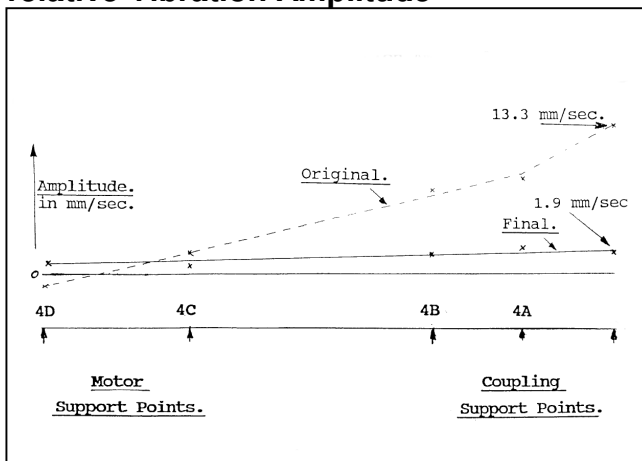
**Fig 6: Plan View showing relative Vibration Amplitude**

Fig 6 shows the new data plotted against the old for the plan view of the relative movement of the edge of the bed.
